# Home Report

# Single Survey

<b>Property Address</b>	Flat 11, The Abbey Church St Benedict's Abbey Fort Augustus PH32 4DE
<b>Reference</b>	Reference: IS202503-21601
<b>Customer Name</b>	Santon Highlands Limited
<b>Date of Inspection</b>	27th March 2025
<b>Surveyor's name, qualifications and office</b>	Graham Forbes MRICS  DM Hall LLP Chartered Surveyors Hope House, Cradlehall Business Park, Castlehill Drive Cradlehall Inverness IV2 5GH  Tel: 01463 241077  email: invernessresidential@dmhall.co.uk
<b>Prepared By</b>	DM Hall LLP

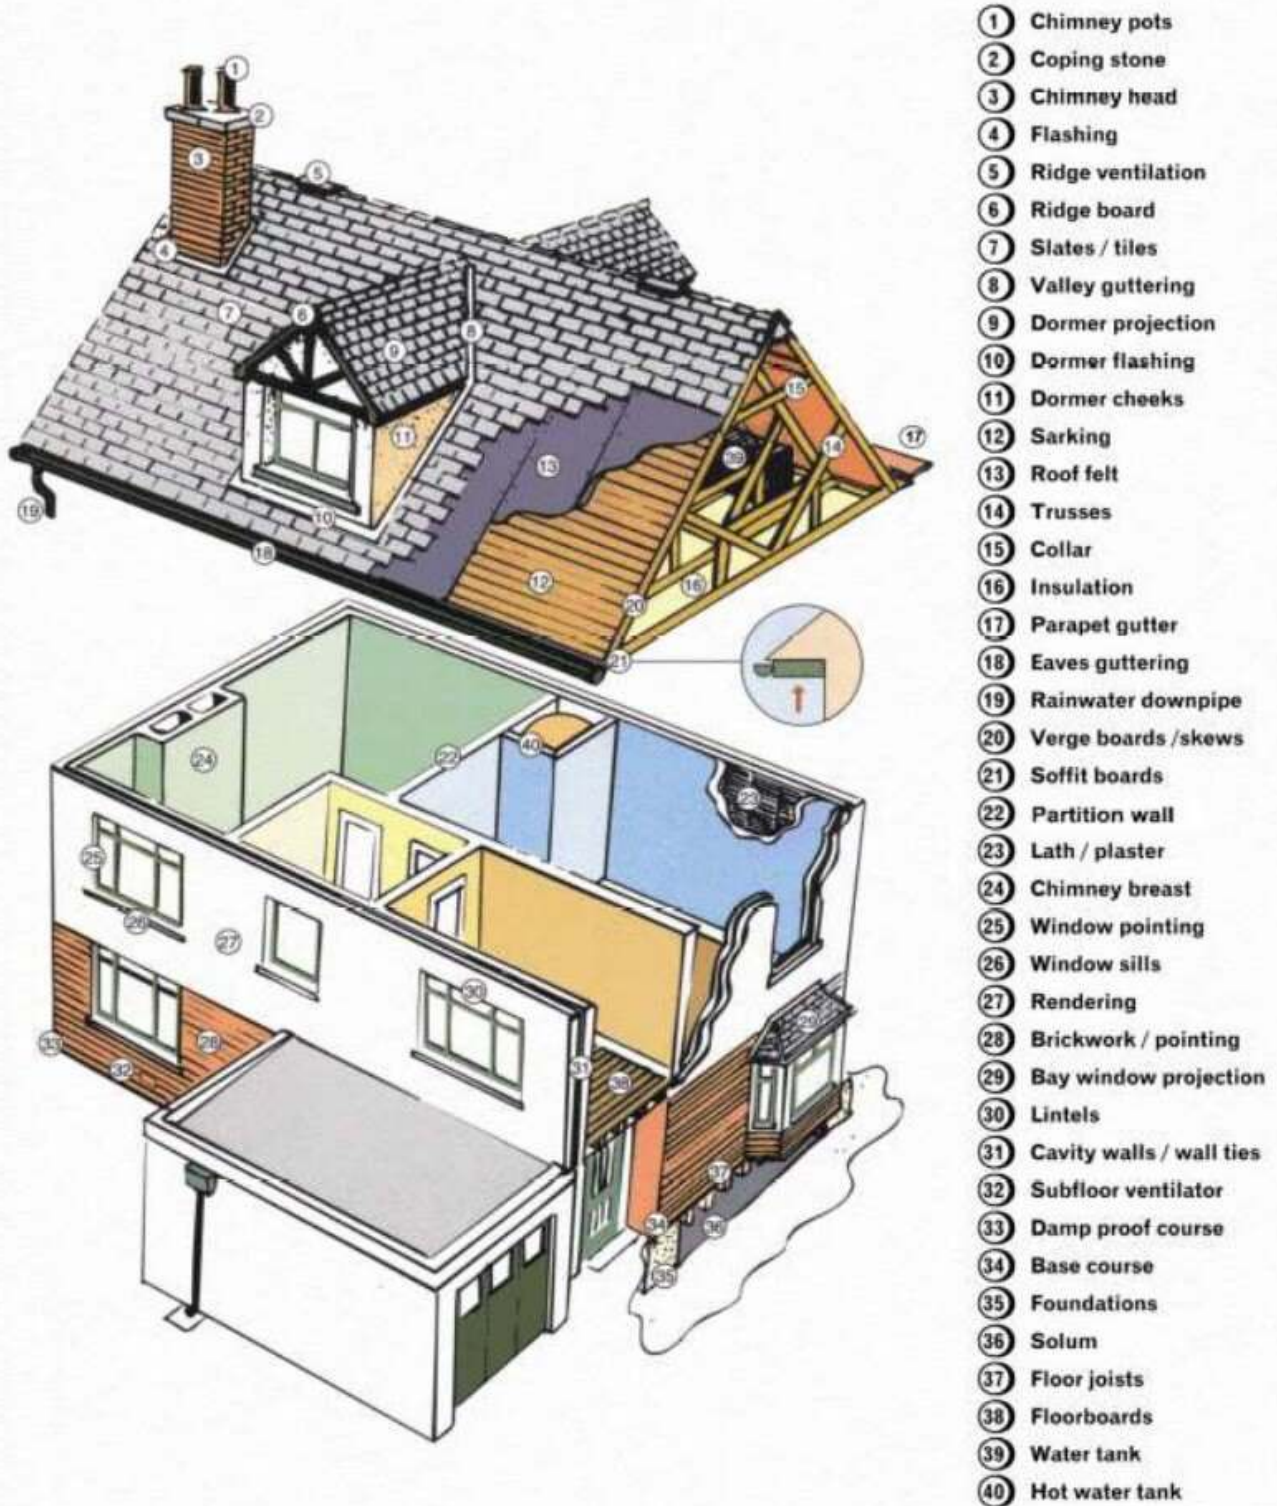
## Sectional Diagram showing elements of a typical house

Reference may be made in this report to some or all of the above component parts of the property. This diagram may assist you in locating and understanding these items.

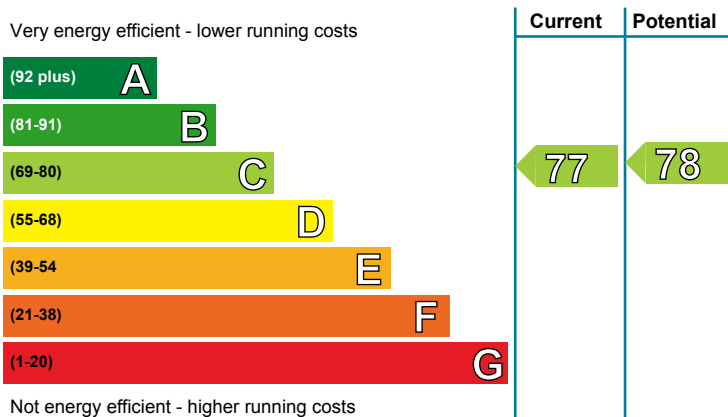
## Energy Efficiency Rating

This graph shows the current efficiency of your home, taking into account both energy efficiency and fuel costs. The higher this rating, the lower your fuel bills are likely to be.

Your current rating is **band C (77)**. The average rating for EPCs in Scotland is **band D (61)**.

The potential rating shows the effect of undertaking all of the improvement measures listed within your recommendations report.

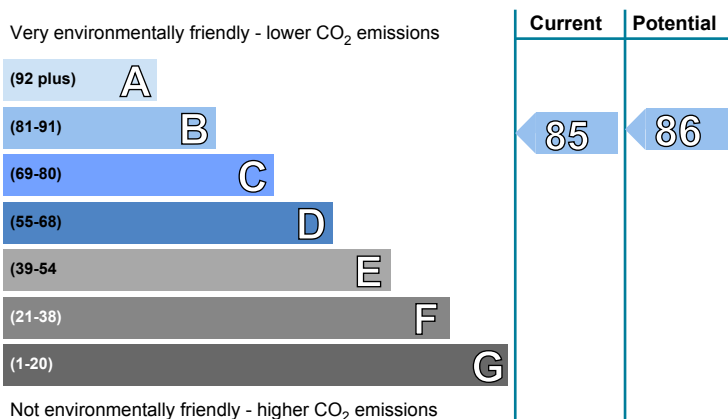
## Environmental Impact (CO<sub>2</sub>) Rating

This graph shows the effect of your home on the environment in terms of carbon dioxide (CO<sub>2</sub>) emissions. The higher the rating, the less impact it has on the environment.
