Home Report

Scottish Single Survey

Property address	8 Raeside Grove Newton Mearns Glasgow G77 5GQ
-------------------------	--

Prepared by	Shepherd Chartered Surveyors
--------------------	------------------------------

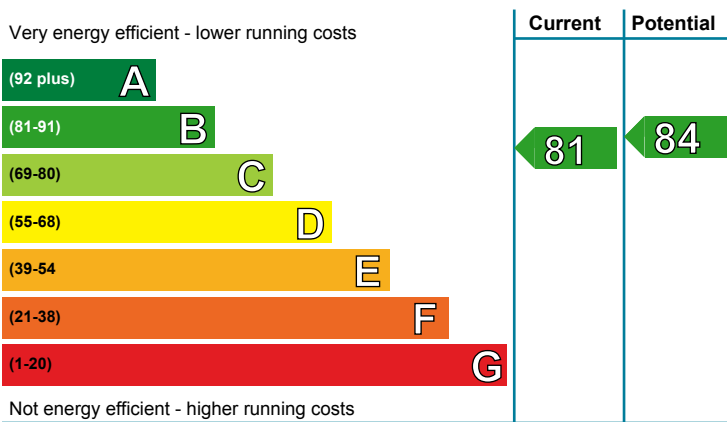
Energy Efficiency Rating

This graph shows the current efficiency of your home, taking into account both energy efficiency and fuel costs. The higher this rating, the lower your fuel bills are likely to be.

Your current rating is **band B (81)**. The average rating for EPCs in Scotland is **band D (61)**.

The potential rating shows the effect of undertaking all of the improvement measures listed within your recommendations report.
